INSPECTION REPORT

Inspection Address **2012 anystreet Drive**
Orleans, Ontario
K4T 1W1

PROPERTY INSPECTION REPORT

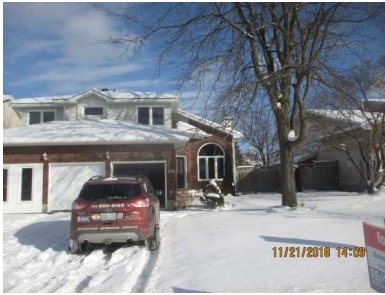
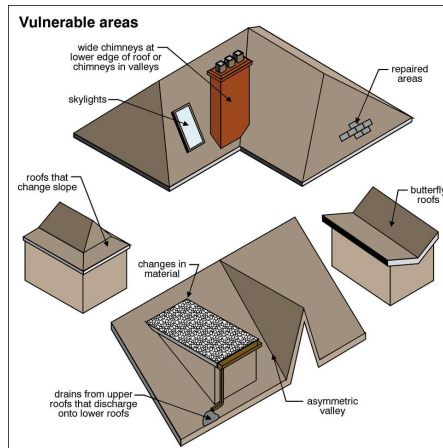
1

**LOCATION:** Various Locations**SYSTEM:** Roof**CONDITION:** Vulnerable areas.**EXPLANATION:** Roof valleys, change in slope and areas where snow, ice and heavy rain accumulate may be prone to leakage.**IMPACT/CONSEQUENCES:** These vulnerable areas should be monitored for heavy snow and ice buildup in winters as well as during heavy rainfall in the summer. Areas adjacent to flat roofs are particularly vulnerable to this condition as evaporation from the surfaces is restricted. Leaves and debris from trees will also clog the roof's drainage system.**RECOMMENDED ACTION:** Monitor

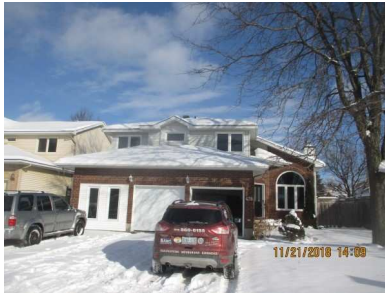
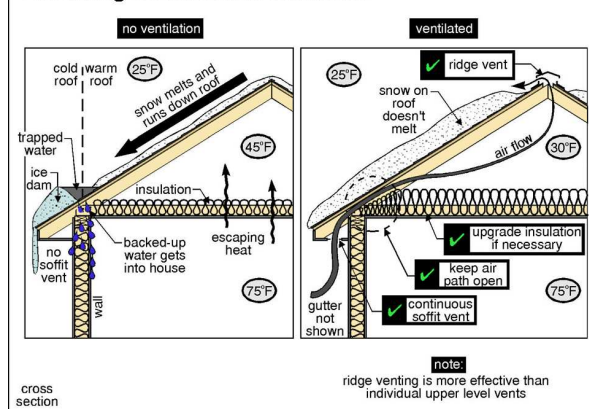
2

**LOCATION:** Various Locations **SYSTEM:** Roof**CONDITION:** Ice damming is visible on shingle roof**EXPLANATION:** Ice damming is visible is evident on portions of the roof cover.

IMPACT/CONSEQUENCES: An ICE DAM refers to snow melt that occurs on a roof during the winter as a result of a warm attic or warm roof cover. The snow melt subsequently freezes on the eave or in the gutters. More snowmelt meets this ice dam and is forced up the roof, under the shingles and into the house. This should be watched for during the winter months. The potential for ice dams can vary with the severity of the winter. In extreme conditions, all homes are at risk of leakage from ice damming. Severe ice dams can result in roof leakage, typically near the eaves. Snow removal is one method of reducing the risk under these conditions. Other solutions include better attic insulation and ventilation, eave protection below the roof coverings, or the installation of heating cables on the roof

RECOMMENDED ACTION: Investigate and Remedy**Preventing ice dams with ventilation**

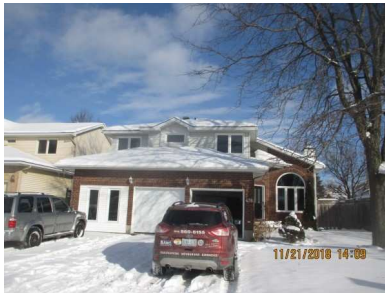
3

**LOCATION:** Roof, Upper, Front **SYSTEM:** Roof**CONDITION:** Gutter is missing**EXPLANATION:** Gutter is observed to be missing. Gutters provide a controlled means of collecting and discharging water away from the structure.

IMPACT/CONSEQUENCES: Gutters are a key component in the controlled drainage of run-off water away from the home's exterior elements. Gutters that are missing may result in water saturation of soils near the foundation during rains, which in turn can result in basement moisture or leakage issues. Repair should include installing new gutter sections and assuring that water freely flows and drains from the gutter.

RECOMMENDED ACTION: Install

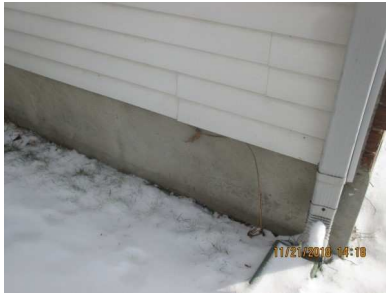
4

**LOCATION:** Various Locations**SYSTEM:** Roof**CONDITION:** Downspout discharges too close to house

EXPLANATION: The discharge point for the downspouts is observed to be near a foundation wall. Water discharge should be as far from the foundation wall as practical to prevent soil erosion and water saturation near the foundation.

IMPACT/CONSEQUENCES: Downspouts are a key component in the controlled drainage of run-off water away from the home's exterior elements. Downspout end terminations that are missing may result in water saturation of soils near the foundation during rains, which in turn can result in basement moisture or leakage issues. It is recommended that the point of discharge be at least 6' (2 m) from the foundation; repair should include installing a downspout extension. The downspout assembly should assure that water freely flows and drains at a suitable distance from the foundation wall.

RECOMMENDED ACTION: Monitor closely.

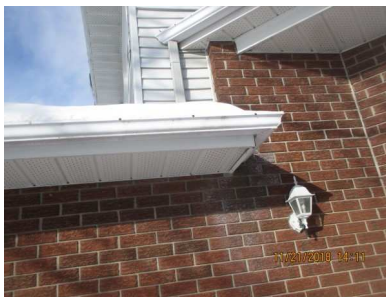
5

**LOCATION:** Various Locations**SYSTEM:** Roof**CONDITION:** Downspout discharges onto lower roof surface

EXPLANATION: Downspouts that drain onto lower roof surfaces will result in deterioration of roof singles in the discharge path. The concentrated water flow erodes the protective granules from the surface of the shingles, which in turn reduces the protection from the sun's ultraviolet rays.

IMPACT/CONSEQUENCES: Premature roof surface deterioration will occur in the areas near the concentrated water flow from the downspout discharge. Repairs to affected shingles can be anticipated prior to the life expectancy of the remaining areas of the roof. Close monitoring is suggested; if possible, downspout extensions should be added, or the drainage modified such that discharge will not be to roof surfaces.

RECOMMENDED ACTION: Monitor closely.

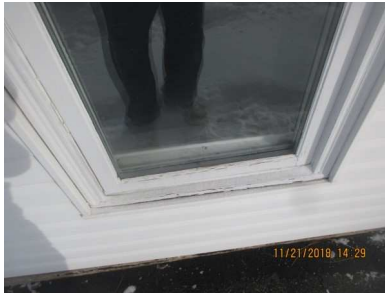
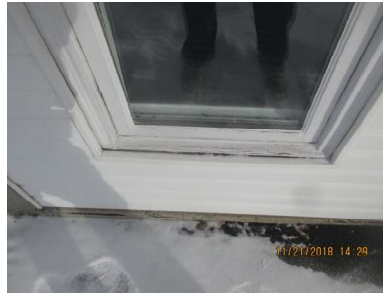
1

LOCATION: Garage at front **SYSTEM:** Exterior

CONDITION: Window is deteriorated

EXPLANATION: The overall condition of the exterior window(s) is observed to be deteriorated, such that operability and performance characteristics are impaired. Exterior window operation and performance considerations include: ability to restrict forced entry; ability to open and close with relative ease; ability to securely close and latch; ability to restrict entry of air, water, and pests. Window components should all be maintained in sound condition.

IMPACT/CONSEQUENCES: A priority consideration for windows is that they meet each of their key operability and performance requirements. Failure to take corrective action may result in safety issues and damage to the home and contents. Immediate repair/replacement of affected window components should be considered as a priority action. A qualified door/window contractor may be required to implement action needs.

RECOMMENDED ACTION: Repair

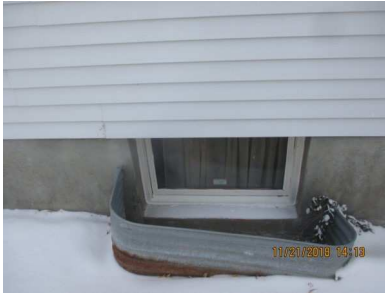
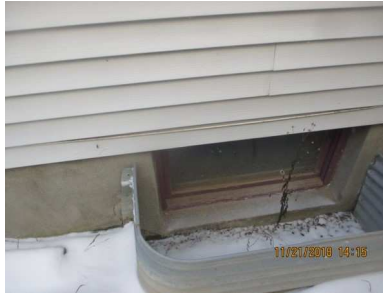
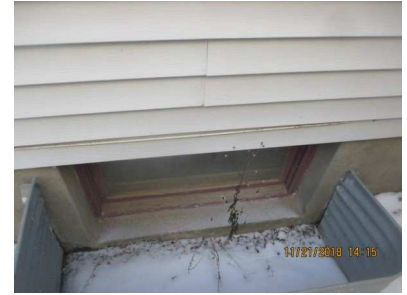
2

**LOCATION:** Basement windows **SYSTEM:** Exterior**CONDITION:** Window unit (s) are older; performance affecting**EXPLANATION:** Windows in general are older units and require ongoing repairs and maintenance. Exterior window operation and performance considerations include: ability to restrict forced entry; ability to open and close with relative ease; ability to securely close and latch; ability to restrict entry of air, water, and pests.**IMPACT/CONSEQUENCES:** A priority consideration for exterior windows is that they meet each of its key operability and performance requirements. Immediate repair/replacement of affected window components should be considered as a priority action. A qualified door/window contractor may be required to implement action needs.**RECOMMENDED ACTION:** Repair or replace

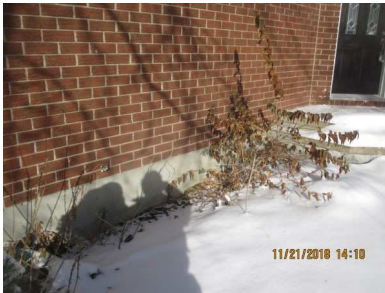
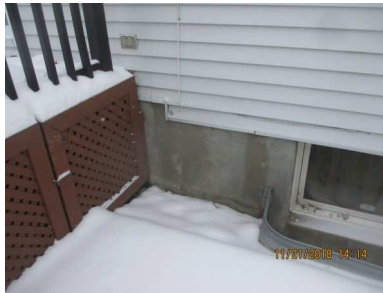
3

**LOCATION:** Throughout **SYSTEM:** Exterior**CONDITION:** Grading near foundation has settled**EXPLANATION:** The grading of soils near the foundation has settled, such that the slope is not away from the home.**IMPACT/CONSEQUENCES:** Grading should be sloped to promote drainage away from the foundation of the home. Water accumulation near the foundation may lead to foundation and basement dampness issues. This condition should be closely monitored; where basement dampness or foundation cracks are noted, remedial action is recommended to improve the grade and assure effective drainage will occur.**RECOMMENDED ACTION:** Review

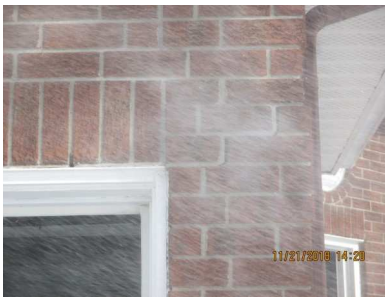
5

LOCATION: Front above south garage door

CONDITION: Exterior masonry wall displays settlement

EXPLANATION: The degree and nature of cracks through brick and/or mortar is such that settlement of the supporting foundation is indicated.

IMPACT/CONSEQUENCES: When a portion of the foundation has settled, stresses from this action has resulted in cracks and movement in the brick and mortar. A home inspection cannot determine whether the condition is dynamic (e.g. whether further settlement may occur; whether the condition of the wall will change over time; etc.) or static (e.g. whether the current condition is stable and no further change in the condition of the foundation or bricking will occur). As a minimum, this condition should be monitored for change over time. Evaluation by a foundation and/or masonry specialist should be considered.

RECOMMENDED ACTION: Monitor; Consult Specialist

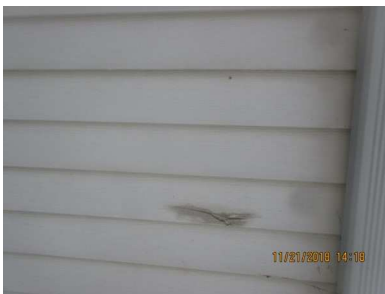
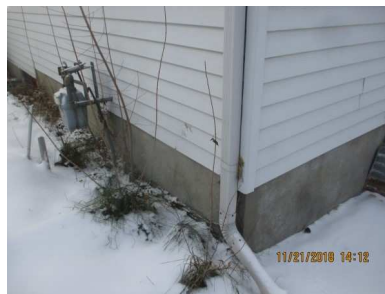
6

LOCATION: Exterior Left Wall

CONDITION: Exterior siding is damaged

EXPLANATION: Damage is noted in the exterior siding

IMPACT/CONSEQUENCES: If the damage results in exposing underlying materials otherwise protected by the siding, water penetration is a possible consequence. Damaged exterior wall coverings are cosmetically detracting.

RECOMMENDED ACTION: Replace

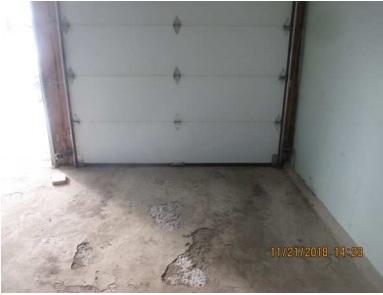
7

LOCATION: Garage all vehicle doors

CONDITION: Vehicle door safety beams were too high

EXPLANATION: The vehicle door safety beams were observed to be at a height that a small child can be below the beam without causing the door opener to react.

IMPACT/CONSEQUENCES: The safety beam is a device that stops the vehicle door from closing, and causes the door to reverse direction, when the light beam is disrupted. This is intended to prevent injury to people and to prevent damage to objects should the beam be broken while the door is closing. This is a safety concern; immediate action is required to ensure door downward motion is arrested and reversed when the beam is disrupted.

RECOMMENDED ACTION: Adjust, repair, or replace.

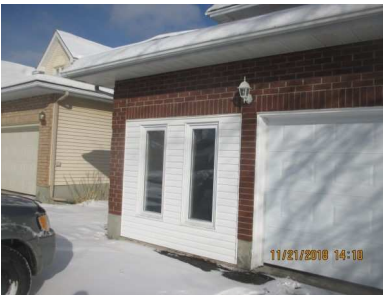
8

LOCATION: Centre door

CONDITION: Vehicle door opener is inoperative

IMPACT/CONSEQUENCES: The intended operation of the door opener could not be verified as the unit failed to operate under normal operating conditions and with installed control devices.

RECOMMENDED ACTION: Adjust, repair, or replace

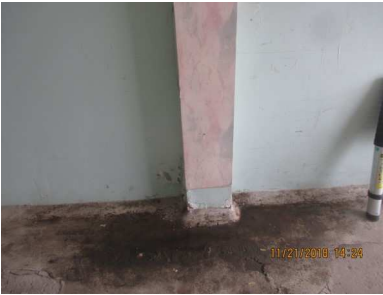
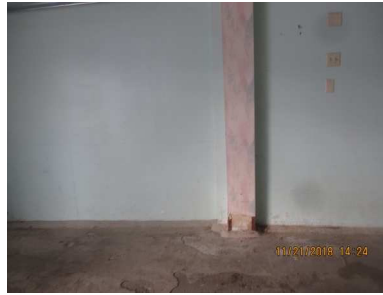
9

LOCATION: Garage at the base of side columns

CONDITION: Garage/house stains on wall/ceiling, evidence of prior leak is suspected

EXPLANATION: Examination of a wall/ceiling in the garage wall/ceiling system has indicated that there may be a prior/active water leak through the roof system. Water staining and/or water damage is observed. Conditions at the time of inspection do not permit a comment to be made as to whether the condition is current and active, or whether the leak has been previously identified and corrected.

IMPACT/CONSEQUENCES: Investigation is warranted to determine whether the observed condition is active, or whether the condition has been corrected. If the condition is active and current, water penetration past the roof system can cause significant and costly damage to the structure, interior features, and interior contents of a home. Water penetration can lead to mold and rot issues within the structure with possible consequential health effects and costly remedial actions. Note that the home inspection cannot fully assess the extent of damage, as this often involves invasive activities such as removing wall/ceiling finishes, etc. If the condition has been corrected, the nature of the repairs should be queried and understood.

RECOMMENDED ACTION: Query Cause; Repair If Required; Monitor For Recurrence

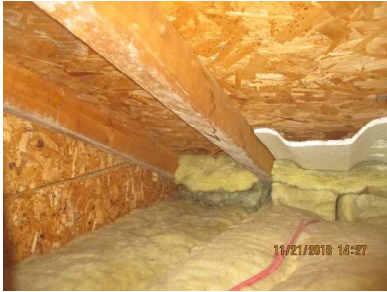
10

LOCATION: Garage **SYSTEM:** Exterior

CONDITION: Attic access frame is not sealed to ensure a gas-tight barrier

EXPLANATION: Gaps are noted between the attic hatch frame and the ceiling. These gaps should be sealed to assure that fumes from the garage cannot migrate into the attic/home.

RECOMMENDED ACTION: Complete

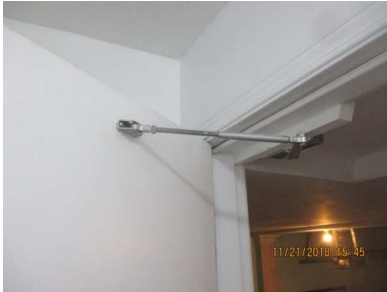
11

LOCATION: Garage **SYSTEM:** Exterior

CONDITION: Garage/house door closer between the house interior and garage needs adjustment.

EXPLANATION: The automatic door closer on the door between the house and garage is improperly adjusted. This device should cause the door to close, latch, and seal when the door is used. The intent is to assure that a gas-tight barrier is maintained between the house and the garage.

RECOMMENDED ACTION: Adjust

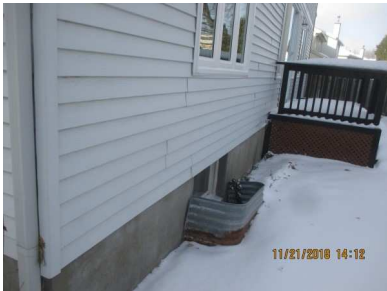
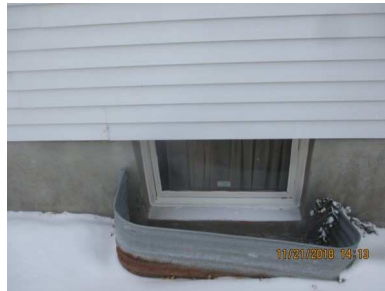
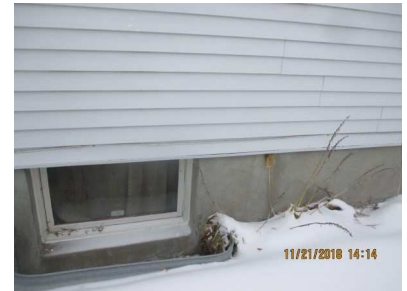
12

LOCATION: Throughout **SYSTEM:** Exterior

CONDITION: Window well Is Damaged.

EXPLANATION: Window well Is observed to be damage during inspection.

IMPACT/CONSEQUENCES: Basement windows serves several functions, including facilitating a proper positive slope at the foundation, preventing water infiltration through the exterior wall. Moisture has the greatest potential for damage; unintended water infiltration into the house can cause significant damage to surfaces and property, and if not corrected, may lead to damage and rot to structural elements. Installing window wells at the noted location should be performed at the earliest opportunity; preventative maintenance should include reviewing and repairing exterior caulking at all doors, windows, and wall penetrations at least twice a year.

RECOMMENDED ACTION: Repair/Replace

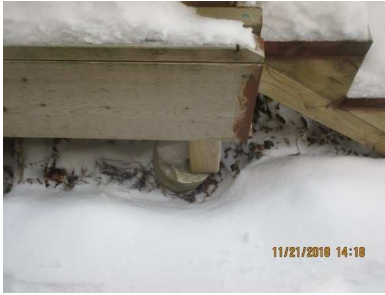
13

**LOCATION:** Deck Left Side **SYSTEM:** Exterior**CONDITION:** Deck columns are deteriorated**EXPLANATION:** Deck columns are in a deteriorated condition; the columns may not be capable of bearing their intended load over time should deterioration continue without intervention.**IMPACT/CONSEQUENCES:** Deck columns are crucial to the support structure of the deck, and structural failure may occur should the columns deteriorate to a degree that they can not bear their intended load. Replacement should be considered. Review by a framing contractor is suggested.**RECOMMENDED ACTION:** Monitor closely; consider replacing

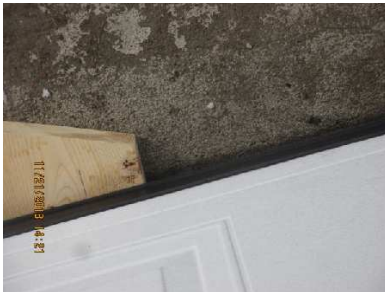
14

**LOCATION:** Garage right door **SYSTEM:** Exterior**CONDITION:** Vehicle door opener failed to auto-reverse with disruption force**EXPLANATION:** The vehicle door opener did not respond to an arresting force when checked during examination of the door opener.**IMPACT/CONSEQUENCES:** The garage door opener should respond to an arresting force that will cause the door to stop downward motion and auto-reverse. This is a safety feature to prevent injury to persons and damage to objects that may be in the path of the closing door. This is a safety concern; immediate action is required to ensure downward motion of the vehicle door is arrested and reversed when resistive force is applied to the door.**RECOMMENDED ACTION:** Adjust, repair, or replace

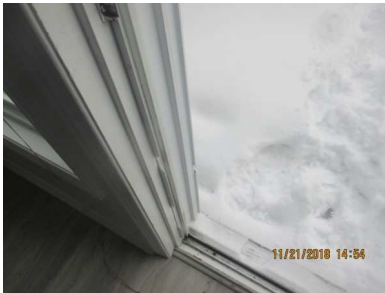
15

**LOCATION:** Exterior Rear Wall-Patio door **SYSTEM:** Exterior**CONDITION:** Exterior door frame/sill is damaged**EXPLANATION:** Deterioration of the door frame is noted.**IMPACT/CONSEQUENCES:** Failure to correct this condition increases the risk of water infiltration and damage to structural components and interior finishes. Replacing the door trim should be considered.**RECOMMENDED ACTION:** Repair, consider replacing

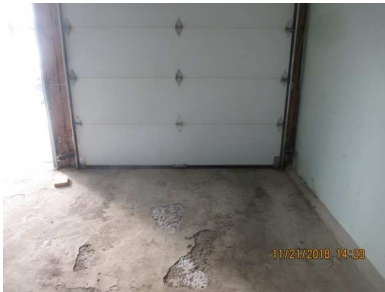
16

**LOCATION:** Garage **SYSTEM:** Exterior**CONDITION:** Garage concrete floor is damaged.**EXPLANATION:** Damage to the concrete floor is usually a result of poor repairs and or salt causing concrete to sprawl on the surface.**IMPACT/CONSEQUENCES:** Usability of the garage may be impaired due to the condition of the pad. Proper drainage may not be possible. The value for future use should be weighted against safety, use, and cost factors.**RECOMMENDED ACTION:** Repair

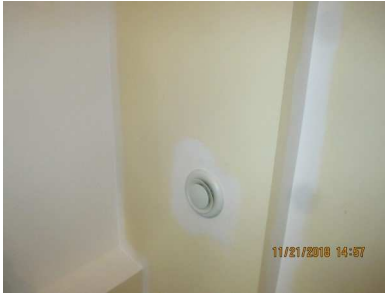
17

**LOCATION:** Garage **SYSTEM:** Exterior**CONDITION:** Intake/Exhaust fan duct terminates in garage**EXPLANATION:** Intake/Exhaust fans shall be ducted to the exterior in accordance with current industry standards.**IMPACT/CONSEQUENCES:** Intake/Exhaust fans must exhaust to the exterior, to ensure moist air is vented to the outside of the home, and to reduce humidity inside the home. Ducts not properly venting may result in moisture-related issues to an interior unfinished area, with mold and rot as possible consequential problems.**RECOMMENDED ACTION:** Repair

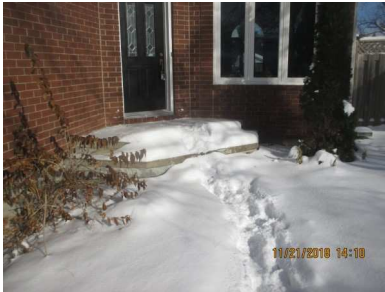
18

**LOCATION:** Various locations **SYSTEM:** Exterior**CONDITION:** Shrubs are located too near to the home's wall and foundation**EXPLANATION:** Shrubs should not be planted in close proximity to the home, such that they have detrimental effects to the foundation and exterior wall elements.**IMPACT/CONSEQUENCES:** Shrubs planted close to a house may over time cause detrimental effects to the exterior components of the home. Shrubs tend to hold moisture near the house, and can promote moisture-related problems to the home's exterior finishes, and in some cases, the structure in the areas of contact. Some shrubs have water-seeking roots, which can extend to and clog the home's foundation drainage system. As a guide, the maximum outermost branches of a mature shrub should be no closer than 2' (60 cm) from any surface of the home.**RECOMMENDED ACTION:** Perform periodic maintenance

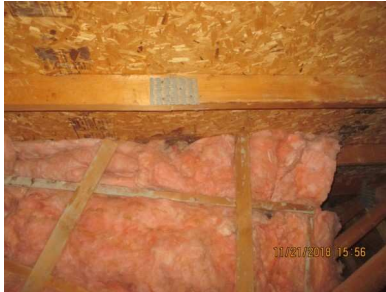
1

LOCATION: Attic **SYSTEM:** Structure

CONDITION: Evidence of water infiltration is observed.

RECOMMENDED ACTION: Consult Specialist

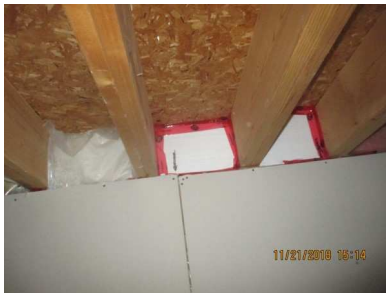
2

LOCATION: Basement **SYSTEM:** Structure

CONDITION: Rigid foam insulation is installed in an exposed location

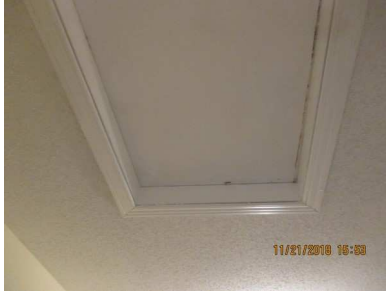
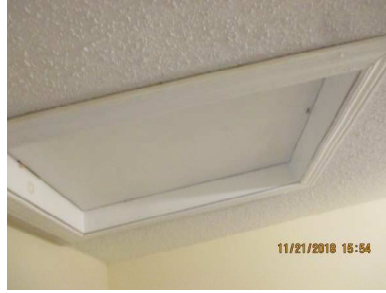
1

**LOCATION:** Master Bedroom **SYSTEM:** Interior**CONDITION:** Attic hatch is damaged/loose**EXPLANATION:** Attic hatch is loose or damaged**IMPACT/CONSEQUENCES:** Attic hatch should be secured to prevent risk of injury from falling trims or plaster.**RECOMMENDED ACTION:** Repair

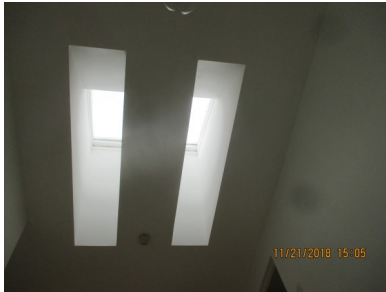
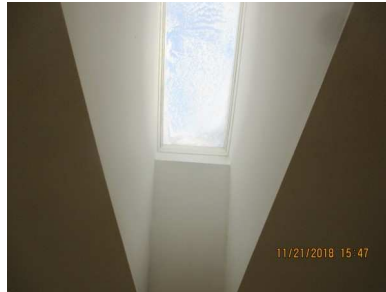
2

**LOCATION:** Ceiling at skylights some areas **SYSTEM:** Interior**CONDITION:** Water stains, drywall repair visible on interior surfaces; indication of prior/active leak**EXPLANATION:** At the time of inspection, water staining, drywall repairs are observed and is suspected to be due to a past condition.**IMPACT/CONSEQUENCES:** Moisture issues can result in significant damage to the home's structure and finishes. A potential safety concern are conditions that may result in the formation of mold or fungus, which in some circumstances can present health issues to occupants of the home. Active leak or moisture conditions require immediate action to assess for cause and damage.**RECOMMENDED ACTION:** Review

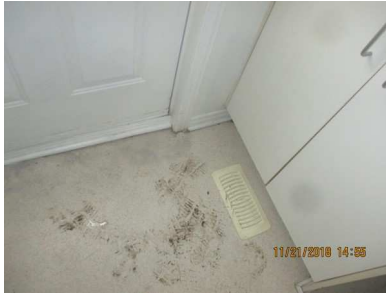
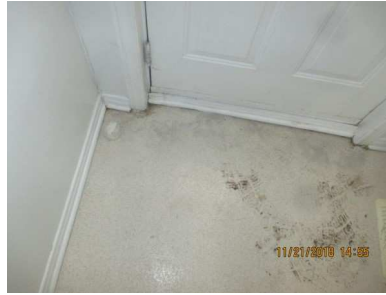
3

**LOCATION:** Exterior door in Laundry Room**SYSTEM:** Interior**CONDITION:** Rot in wood floor elements**EXPLANATION:** Areas of wood rot and deterioration are observed in the floor system. Selective probing indicates loss of fiber strength and integrity. The current and future ability of the subfloor and floor support elements to bear their intended load is suspect.**IMPACT/CONSEQUENCES:** A primary consideration to wood rot issues in the floor system is its ability to bear loads. Repeated wetting also increases the possibility of mold formation and rot, some portions of which may be in areas that are not visible. In certain circumstances, this may present a health risk. The cause of the water damage should be understood and addressed. The integrity of the floor elements displaying rot should be deemed suspect; repairs to remove and replace damaged wood members is recommended.**RECOMMENDED ACTION:** Repair

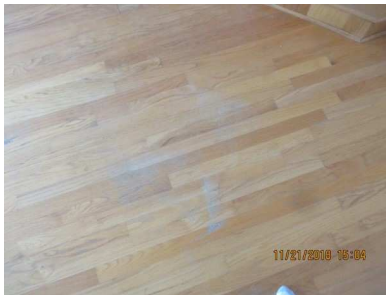
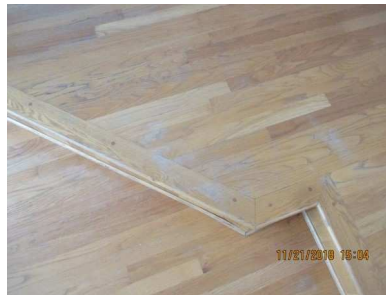
4

**LOCATION:** Various locations **SYSTEM:** Interior**CONDITION:** Wood floor finish is Damaged**EXPLANATION:** Generally damaged finish is due to traffic through the area and physical impact.**IMPACT/CONSEQUENCES:** repair/refinishing is required to preserve the visual appeal of the flooring.**RECOMMENDED ACTION:** Repair

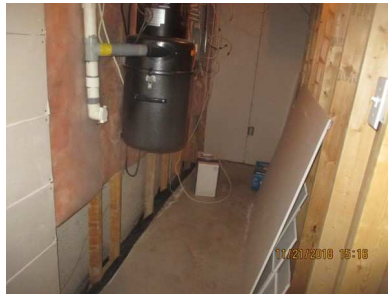
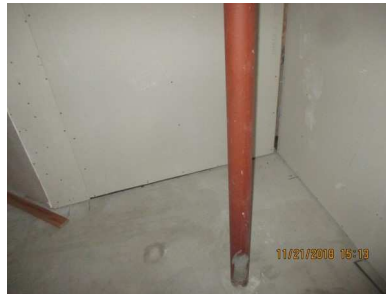
5

**LOCATION:** Basement on edge of floor**SYSTEM:** Interior**CONDITION:** Evidence of prior leak in exterior wall; suspected

EXPLANATION: Examination of a wall/ceiling forming the exterior wall system has indicated that there may be an active water leak through the wall. Water staining and/or water damage is observed. Conditions at the time of inspection do not permit a comment to be made as to whether the condition is current and active, or whether the leak has been previously identified and corrected.

RECOMMENDED ACTION: Query Cause; Repair If Required; Monitor For Recurrence

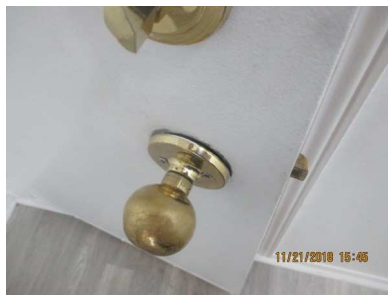
6

**LOCATION:** Garage/House door **SYSTEM:** Interior**CONDITION:** Interior door has damaged hardware

EXPLANATION: Hardware required for proper operation and function of the door is damaged. A primary function of the door is to operate in a manner that ensures the door will open and close with relative ease, and to meet the privacy needs of the home's occupants.

RECOMMENDED ACTION: Repair

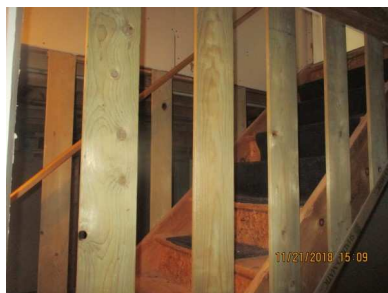
7

**LOCATION:** Basement Stairs**SYSTEM:** Interior**CONDITION:** Guards are unsafe

EXPLANATION: In the opinion of the inspector, the current condition of the guard is such that a condition is observed that presents a significant risk of injury.

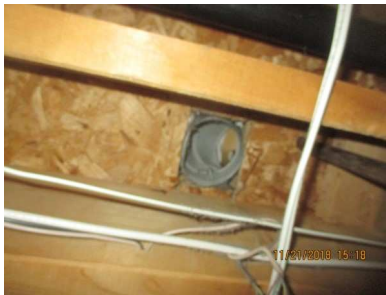
1

**LOCATION:** Basement **SYSTEM:** Heating/Cooling**CONDITION:** Supply duct has come apart at its seams or joints**EXPLANATION:** At the noted location, an air supply duct is observed to have become disconnected.**IMPACT/CONSEQUENCES:** A disconnected supply duct will cause a reduction in the flow of ducted air, resulting in insufficient flow to the intended room or location. As well, this condition may result in air being supplied to an area where it was not intended. In either case, the efficiency of the duct system has been reduced and may not be achieving the intended balanced distribution of conditioned air.**RECOMMENDED ACTION:** Repair**OBSERVATIONS & SUGGESTIONS:**

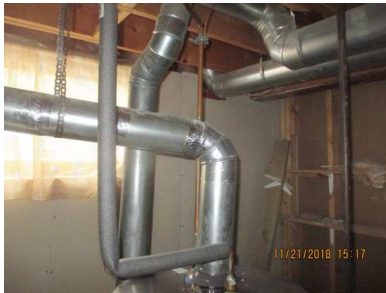
1

LOCATION: Main house unit **SYSTEM:** Plumbing

CONDITION: Water heater mixing Valve is missing or damaged

RECOMMENDED ACTION: Safety Concern | Consult Specialist

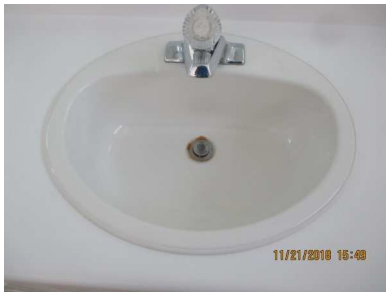
2

LOCATION: Main Bathroom **SYSTEM:** Plumbing

CONDITION: Sink is rusting

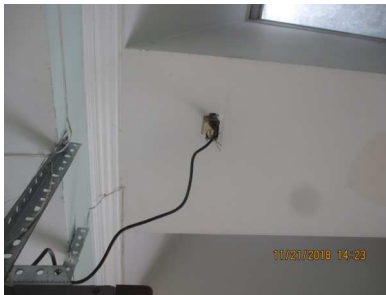
2

LOCATION: Various locations **SYSTEM:** Electrical
CONDITION: Receptacle cover plate is missing
EXPLANATION: A protective cover plate is missing from an electrical outlet.
IMPACT/CONSEQUENCES: A cover plate for receptacles is required to reduce the risk of electrical shock. A suitable cover plate should be immediately installed for safety

RECOMMENDED ACTION: Install
